MASSACHUSETTS INSTITUTE OF TECHNOLOGY CAMBRIDGE, MASS. 02139

Information Processing Center

April 14, 1970

Re: 645 Electrical Problems

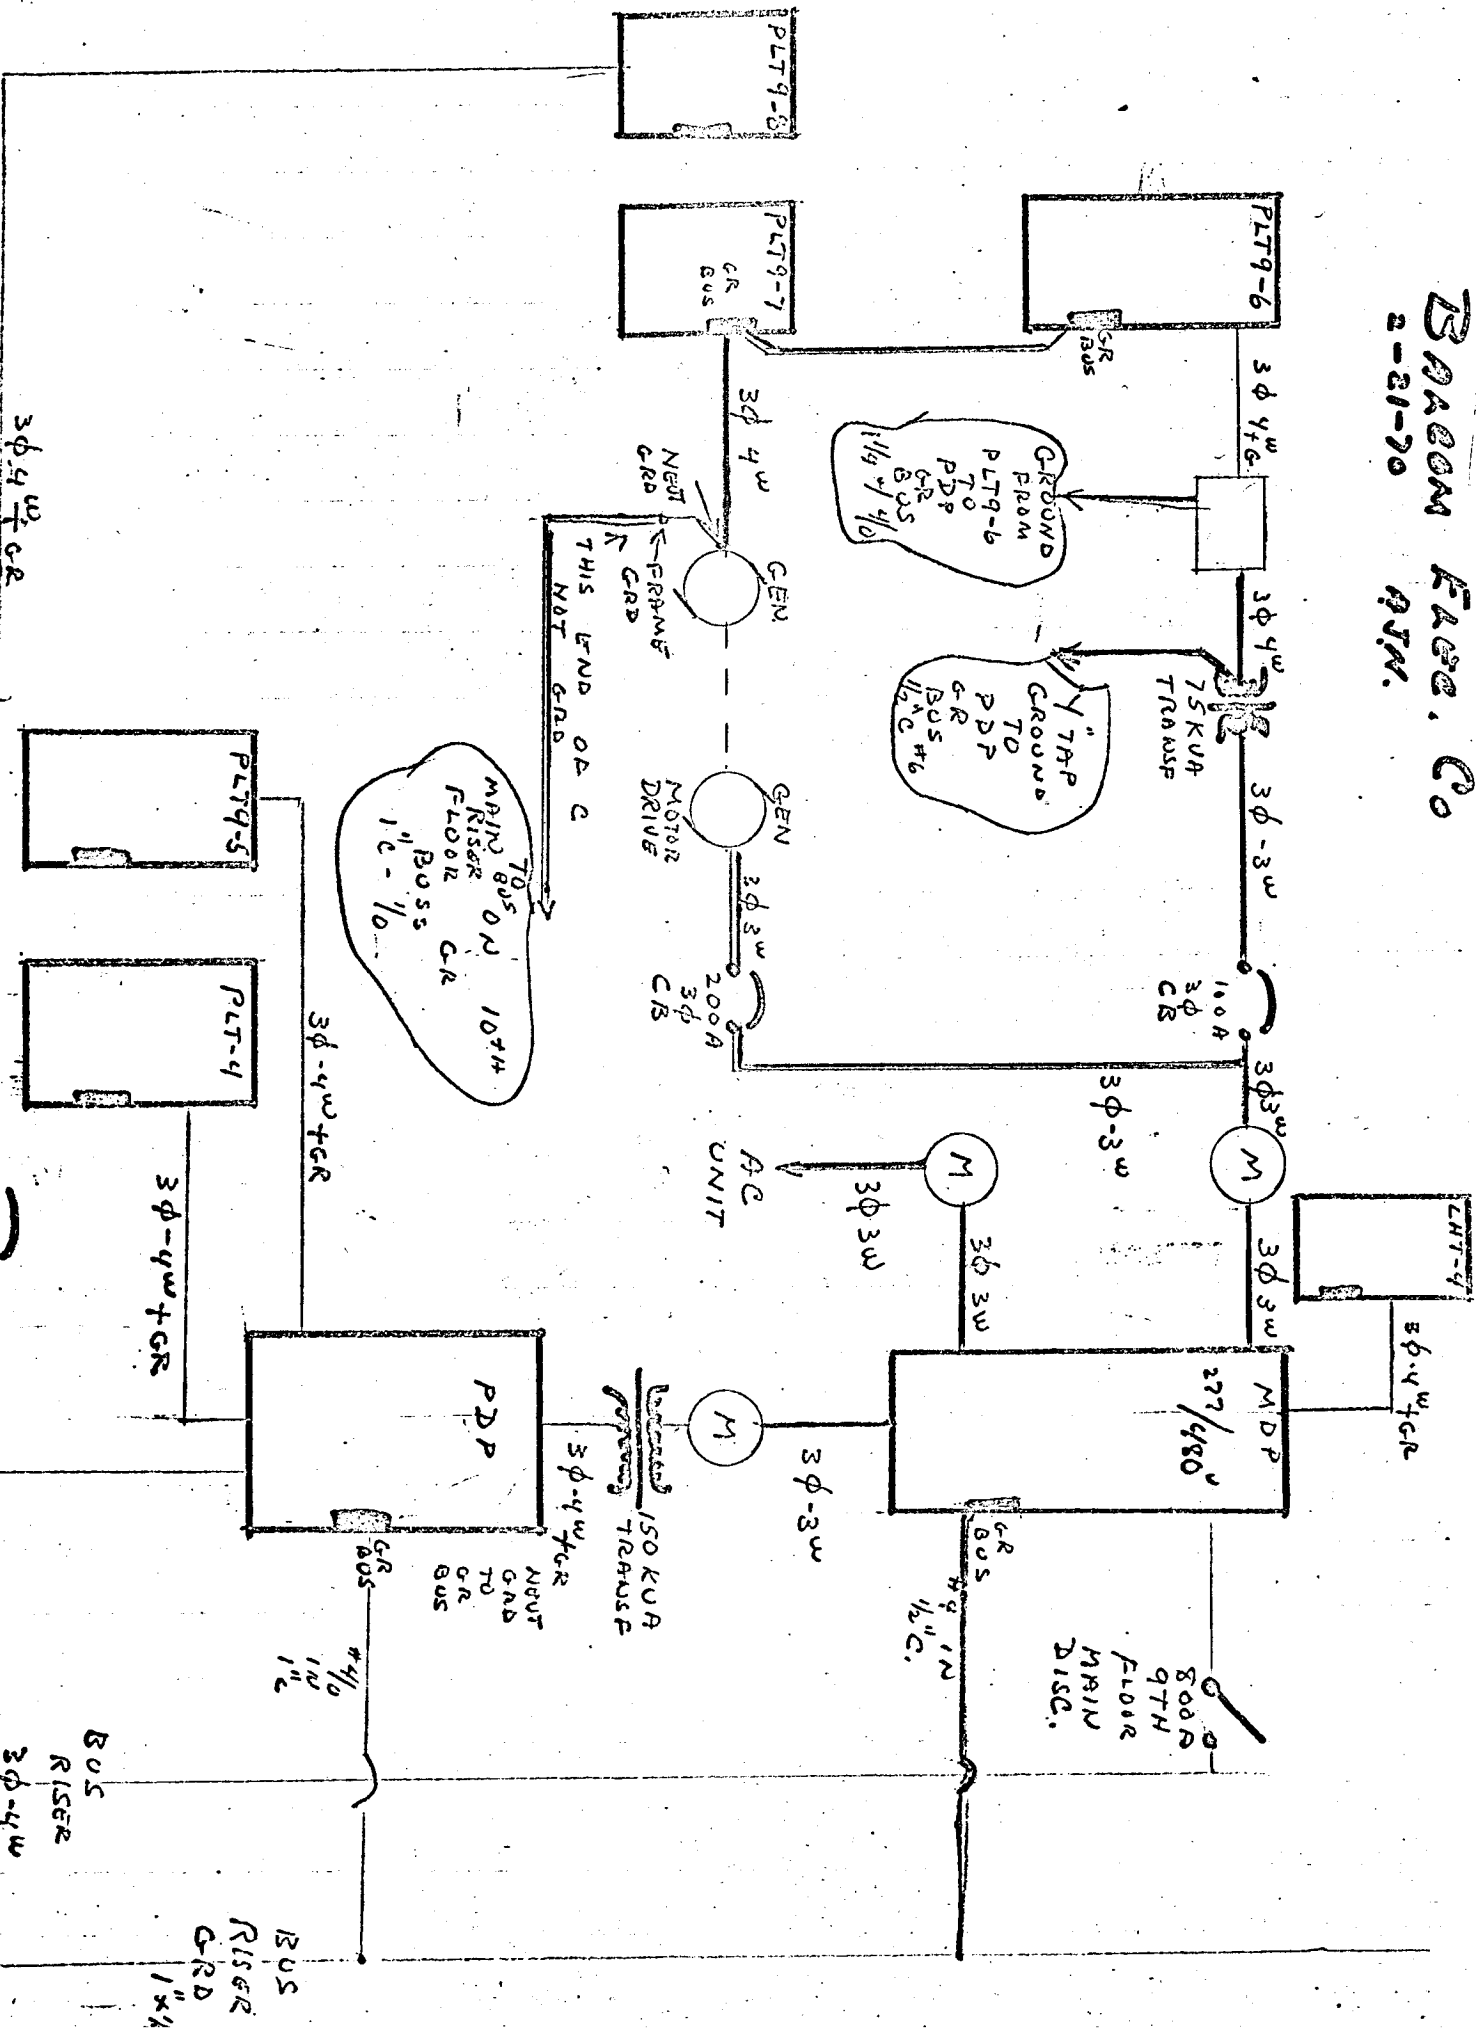
ONE LINE BUS OF POWER DIST

- A. A trace of the ground system was done; a schematic is attached showing the distribution of power from the Main Buses to the various panels, transformers, and the Motor Generator. (Please note that the red lines indicate what we suspect as possible problem areas. A summary of these problem areas is given below.)

RED LINES INDICATE PROBLEM AREAS.

1. The ground wire between the main ground bus and the ground point of the MDP should be the same size wire as the main ground bus.
2. The feeder from the MDP to the 100A 3Ø CB and to the 75 KVA transformer should have a ground wire added in the conduit; this would then ground the 75 KVA transformer, the meter, and the 100A 3Ø CB.

The ground wire should be a #2 wire to be consistent with the secondary copper of the transformer.

3. The ground "daisy chain" should be eliminated between PLT9-6 and PLT9-7.
4. The M.G. prime mover should be grounded by bringing a ground conductor, the same size as the generator output from the MDP ground bus to the prime mover of the M.G. unit. The ground for PLT9-7 should be tied onto this ground.
5. The A.C. Motor Control Center feeding the fans, chillers, and pumps should also have a ground.
6. Remove jumper in Main Switch Board located in basement, the jumper now runs from Neutral to ground and frame ground. The tie point should be made closer to the entrance of the ground wire and neutral bus as they come into the building.
7. A separate ground could be run from all the Computer Equipment to the Main Ground in the basement.
