Remote Characterization of Defects in FRP strengthened Concrete Using the Acoustic-Laser Vibrometry Method

Justin G. Chen¹, Robert W. Haupt², Oral Büyüköztürk¹

¹Department of Civil and Environmental Engineering, MIT
77 Massachusetts Ave., Cambridge, MA 02139
(617) 253-7186, obuyuk@mit.edu

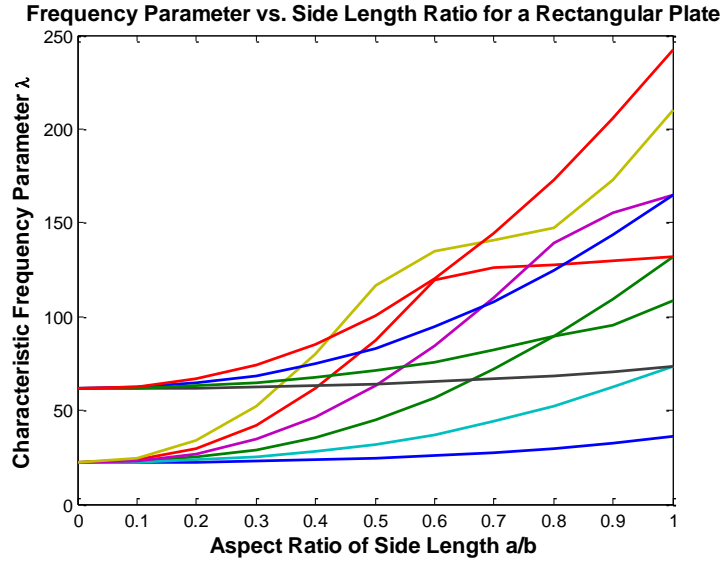
Figure 2: Plot showing frequency parameter λ as a function of defect aspect ratio [11,12]

where D = flexural rigidity of the plate, E = Young's modulus, h = thickness of the plate, ν = Poisson's ratio, ρ = density of the material, a = shorter side length of the plate, b = longer side length of the plate, λ = a frequency parameter that depends on the resonant mode, geometry, and boundary conditions of the plate, and f = resonant frequency. The key parameter here regarding defects of different shapes, despite having more or less the same dimensions is λ which is directly correlated to the frequency of the mode. For the case of a rectangular defect, the vibrational mode and the aspect ratio, a/b dictate the value of λ . As the aspect ratio becomes smaller, or as the defect becomes more crack-like and less square, the resonant frequencies corresponding to different vibrational modes shift, as shown in Figure 2. As the aspect ratio approaches 0, the first seven vibrational modes of a square plate converge to two modes. Therefore, when defects are shaped more like a crack with slender aspect ratios, we expect resonant frequencies to be grouped closer together when the frequencies are normalized to the frequency of the first resonant mode.

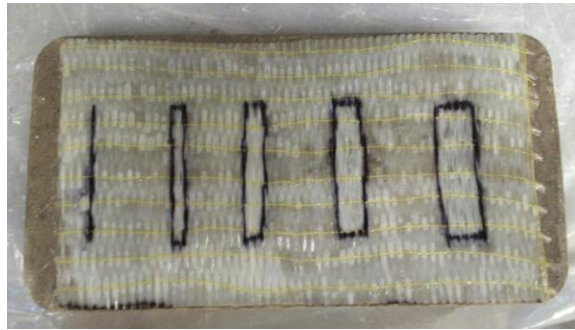
Figure 5: FRPP5, FRP-bonded concrete panel with multiple defects

FRPP5 is a FRP-bonded concrete panel with multiple defects of height 3" with widths of 0.125", 0.25", 0.5", 0.75", and 1" shown in Figure 5. These different crack widths represent aspect ratios of 0.04, 0.08, 0.167, 0.25, and 0.33.

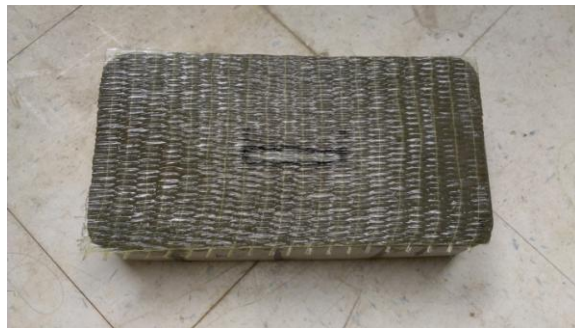
Figure 6: FRPP4, FRP-bonded concrete panel, angled 3" x 0.25" defect

FRPP4 is a FRP-bonded concrete panel, shown in Figure 6 with a 0.25" x 3" defect at the surface where the FRP is debonded, and the void extends into the concrete at an angle approximating a shallow angled crack.

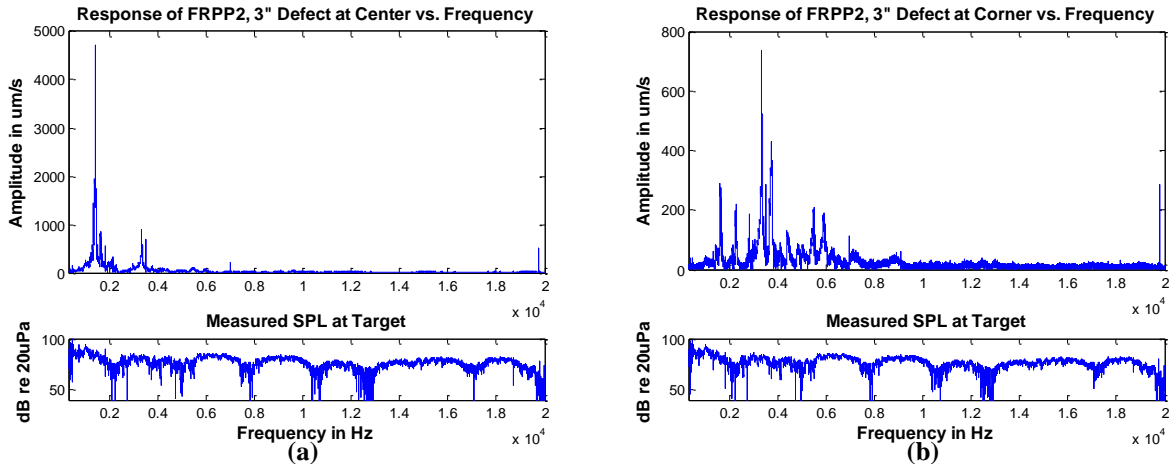
Figure 7: Frequency response velocity spectrum for FRPP2, 3" x 3" defect at the (a) center and (b) corner [9]

The theory presented dictates that for a square defect, the resonant frequencies should be relatively evenly spaced, and as the defect gets more slender and crack-like, the resonant frequencies will tend to group together. In order to study this effect, measurements were made on defects with varying widths of 0.25", 0.5", 0.75", 1", and 3", with constant height of 3". Figure 7 shows measurements on the 3" wide defect FRPP2 at the center and corner. The first resonant frequency in Figure 7b is at 1.6 kHz, while the next two resonant frequencies are at 2.25 kHz and 2.8 kHz,

for ratios of 1.4 and 1.75. The theoretical ratio for a square clamped plate made of isotropic material should be approximately 2, however FRP is a directional material, explaining the discrepancy.

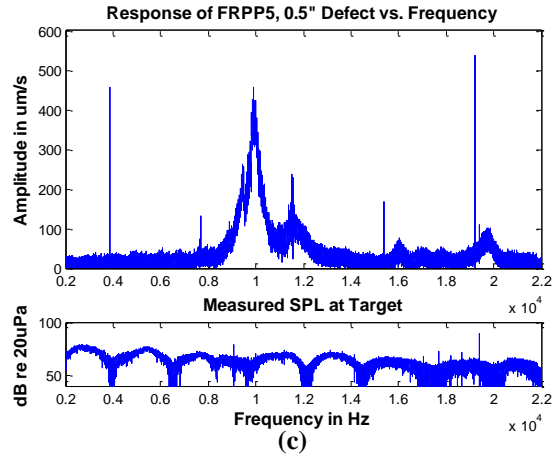
Figure 8: Frequency response velocity spectrum for FRPP5: (a) 1" defect, (b) 0.75" defect, (c) 0.5" defect

Three of the defects of width 0.5", 0.75", and 1" were measured on the FRPP5 specimen, and the response frequency spectrums are shown in Figure 8. The narrower crack defects of 0.125" and 0.25" when measured did not result in a visible vibrational response from the defect, and are not included. For the 1" defect shown in Figure 8a, the first resonant frequency is at 4.15 kHz, the second at 4.5 kHz, and the third at 4.68 kHz. These give ratios of 1.084 and 1.128, which are closer to each other than that of the 3" defect. For the 0.75" defect shown in Figure 8b, the first resonant frequency is at 6.85 kHz, the second at 7.18 kHz, and the third at 7.54 kHz. The ratios are 1.048 and 1.101. For the 0.5" defect shown in Figure 8c, the first resonant frequency is at 9.45 kHz, the second is at 9.9 kHz, and the third visible is at 11.5 kHz. The ratios are 1.048 and 1.217. One possible reason that the third resonant frequency is comparatively higher, might be that the broad peak of the first and second resonant frequencies hides another resonant frequency of lower amplitude.

Qualitatively, the resonant peaks become broader as the crack width is decreased, and this is seen for all three widths of defect. The reason for this broadening could be that the width of the peaks is relatively large compared to the spacing between peaks, and so they might tend to merge to form one peak instead. The width of the peak is related to the quality factor of the resonance which describes the damping, where the narrower the peak, the lower the damping of the resonance.

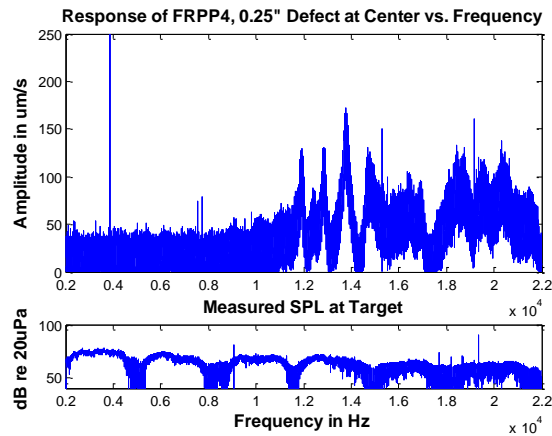
Figure 9: Frequency response velocity spectrum for FRPP4, 0.25" defect

The response spectrum for the FRPP4 angled defect, shown in Figure 9, is quantitatively different than the ones on the FRPP5 specimen. The resonant frequencies are spaced closed together, with the first resonant frequency at 11.9 kHz, and the subsequent ratios for the next two resonant frequencies at 12.4 kHz and 12.9 kHz of 1.042 and 1.084. Qualitatively each frequency peak however is less broad, suggesting that the defect is less damped. This defect is slightly different than the FRPP5 specimen defects because the void is angled beneath the surface, instead of normal to the surface, which may account for the differences. The defect vibration may not be purely due to the vibration of the FRP defect, because the side of the defect with the angled crack may be less of a clamped boundary condition than the other three sides.

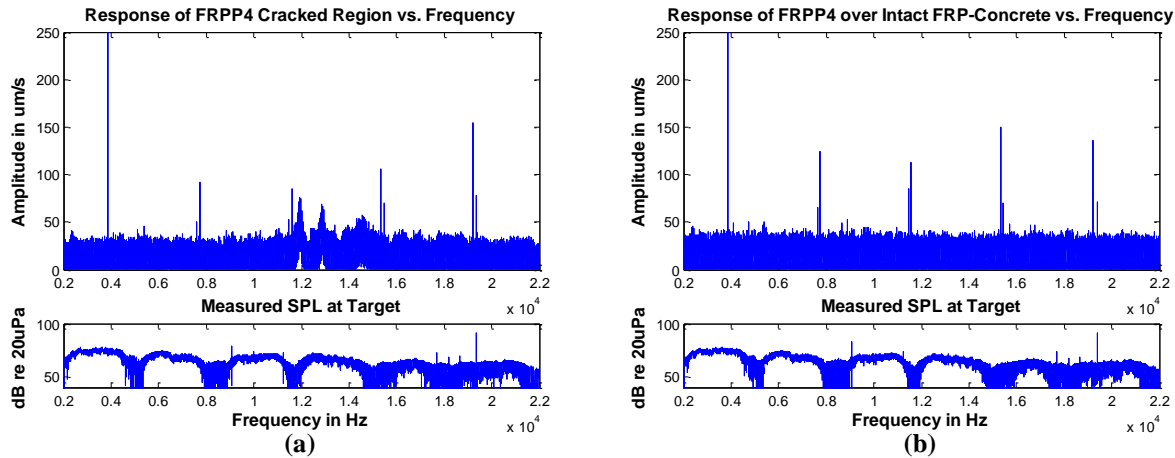
Figure 4: Frequency response velocity spectrums for FRPP4 over (a) cracked region and (b) intact material

Another result from the measurement of the FRPP4 specimen is that a small vibration response was measured over a region where the FRP-concrete system is intact, however there is a crack that extends underneath the surface of the concrete by about 1cm. Figure 4a shows a couple of resonant frequencies around 12 kHz to 14 kHz with amplitudes of approximately 75 $\mu\text{m/s}$ that are distinguishable by eye from the response spectrum over a region where there is intact material and no cracking in Figure 4b, which has several spurious peaks due to some source of noise. This suggests that shallow cracks in concrete may vibrate enough under acoustic excitation to be detected with a laser vibrometer, and the acoustic-laser vibrometry method may be useful for detecting cracking of a thin concrete cover.
